**NASA
Technical
Paper
3160**

**An Examination of the Damage
Tolerance Enhancement of
Carbon/Epoxy Using an
Outer Lamina of Spectra®**

D. G. Lance
and A. T. Nettles
*George C. Marshall Space Flight Center
Marshall Space Flight Center, Alabama*

MSFC Center Director's Discretionary Fund Final Report,
Project No. 90-17

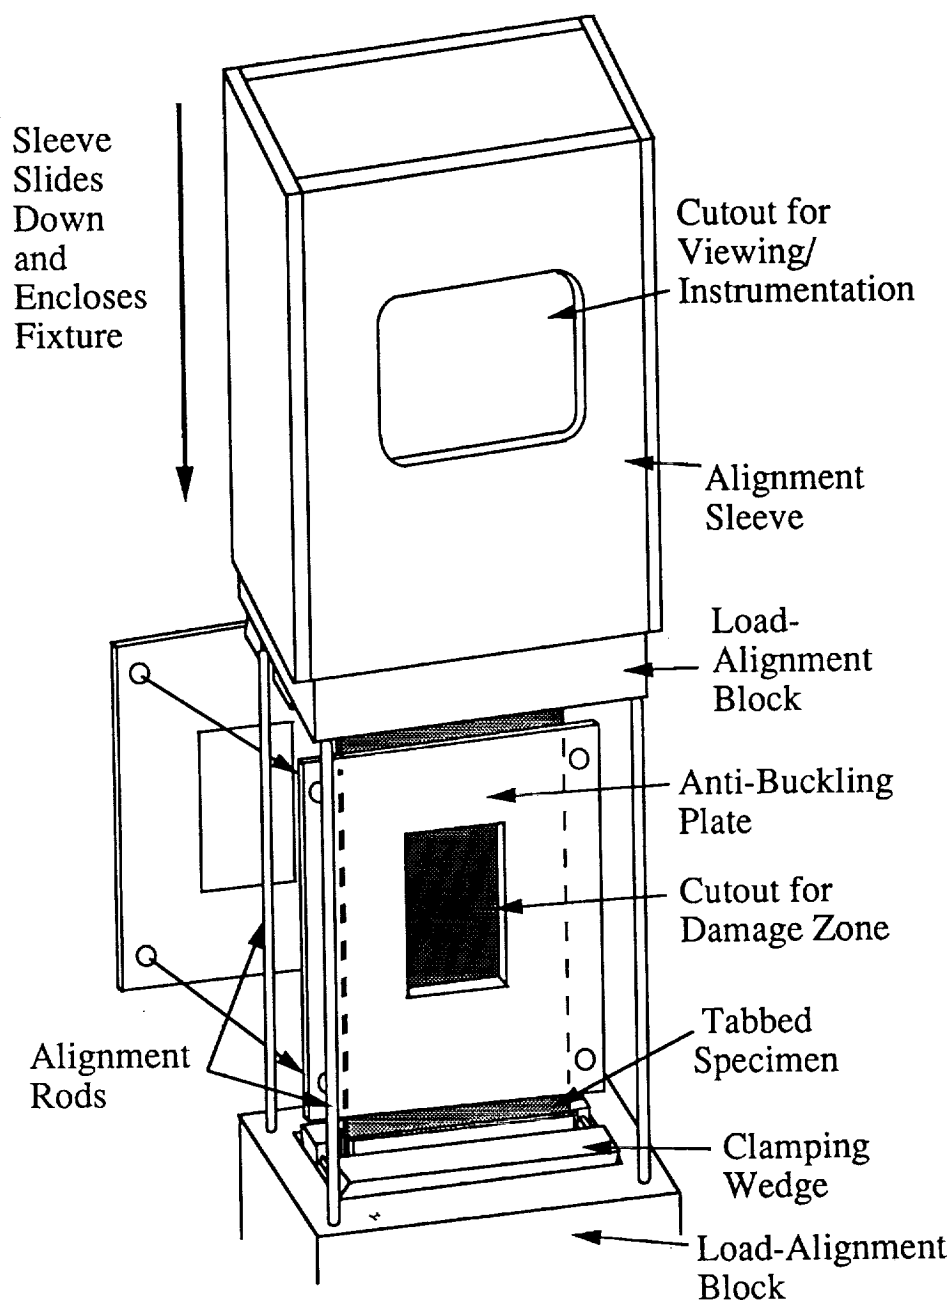
Figure 1. Modified fixture to test residual compression strength.

Compression-after-impact testing was conducted on an Instron 1125 testing machine. The tests were performed at a strain rate of 1.3 mm/min. Six specimens of each configuration were tested. Three specimens without UHMWPE that were not impacted were compression tested for comparison purposes. A drawing of the modified Celanese/IITRI compression test fixture used during this project is presented in figure 1. A patent has been applied for this device and detailed documentation is available.⁵

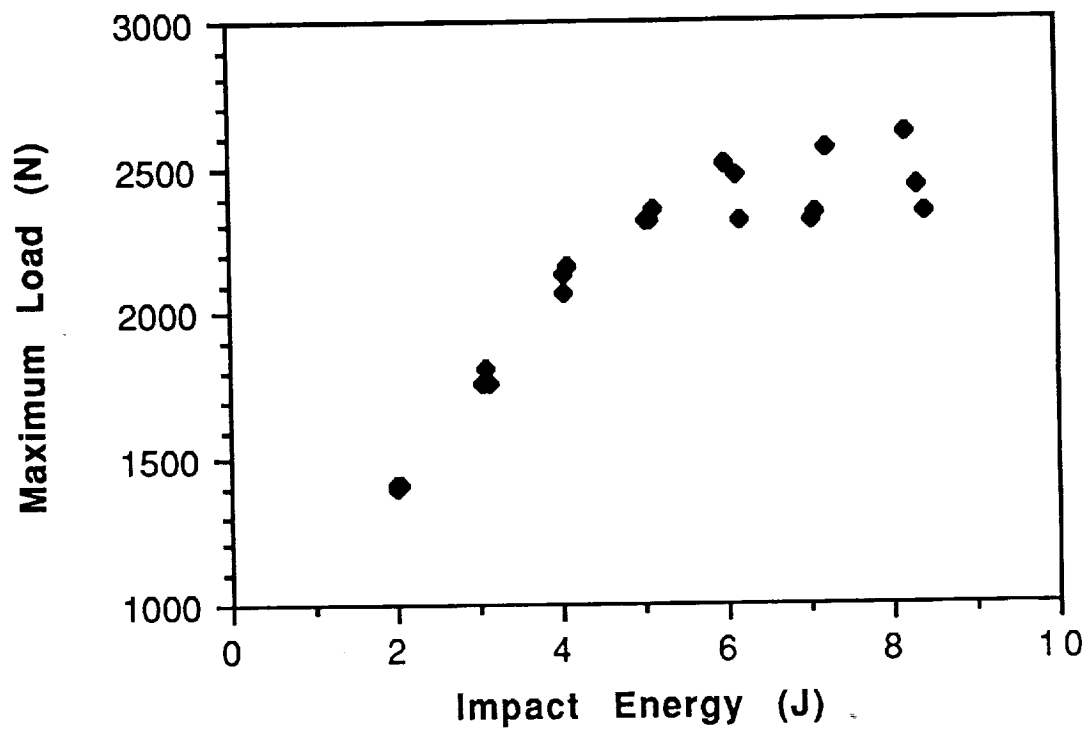
Figure 2. Maximum load versus impact energy for T300/948 without UHMWPE.

Graphs were made which plotted the maximum load of each impact event against the respective impact energy. The plots of each configuration are somewhat linear until the point that fiber breakage occurs. The correlation between the maximum force and increasing impact energy becomes more horizontal and the points become more scattered after fiber breakage initiates. Graphs of each UHMWPE configuration are given in figures 2 through 6. For comparison purposes, all the graphs are superimposed together in figures 7 and 8. Figure 7 shows that the plot of all the materials follows that of an inverse parabolic curve. It also shows that there is no distinctively different curve for each of the configurations used.

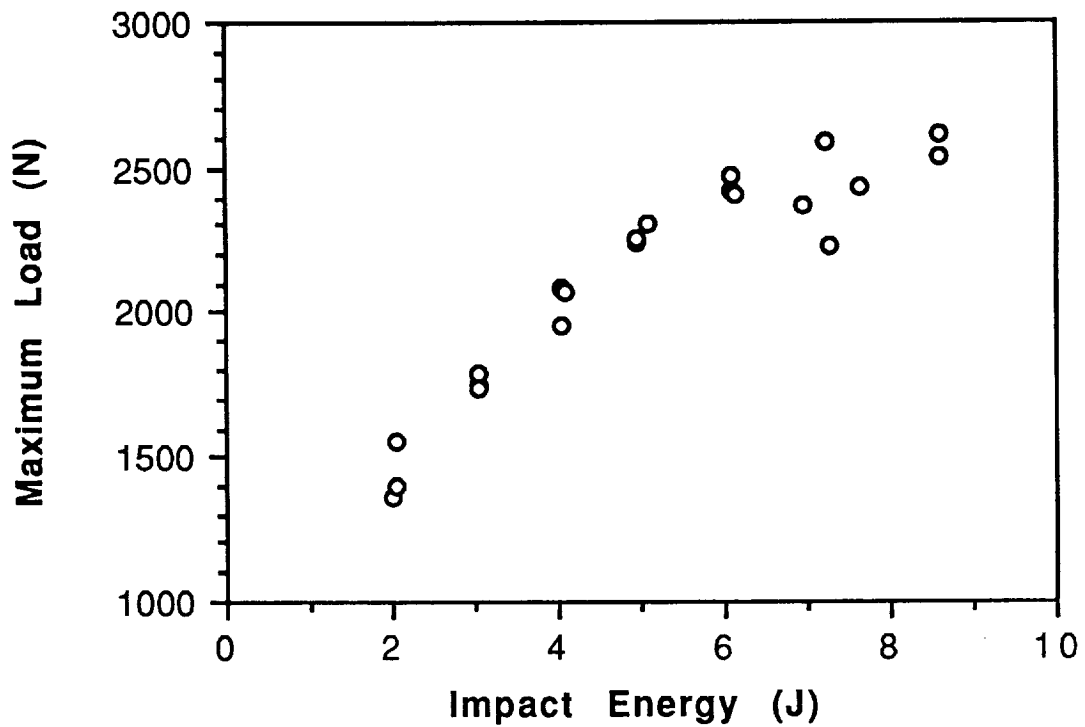
Figure 3. Maximum load versus impact energy for T300/948 with UHMWPE on top face.

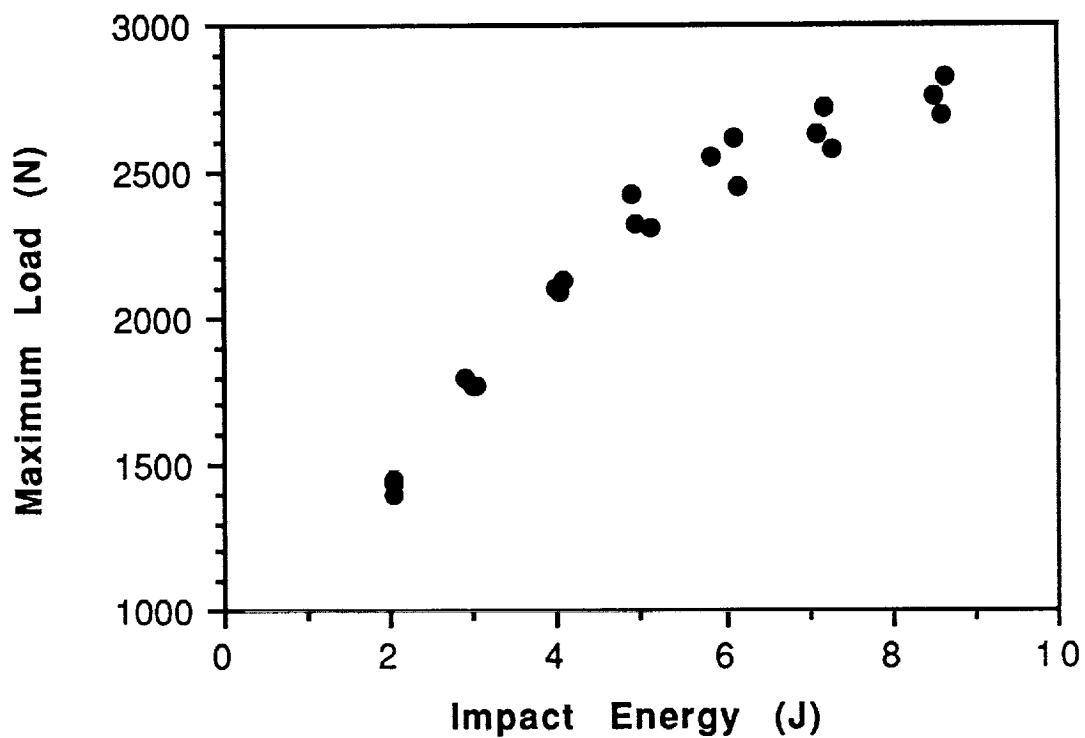
Figure 4. Maximum load versus impact energy for T300/948 with UHMWPE on bottom face.

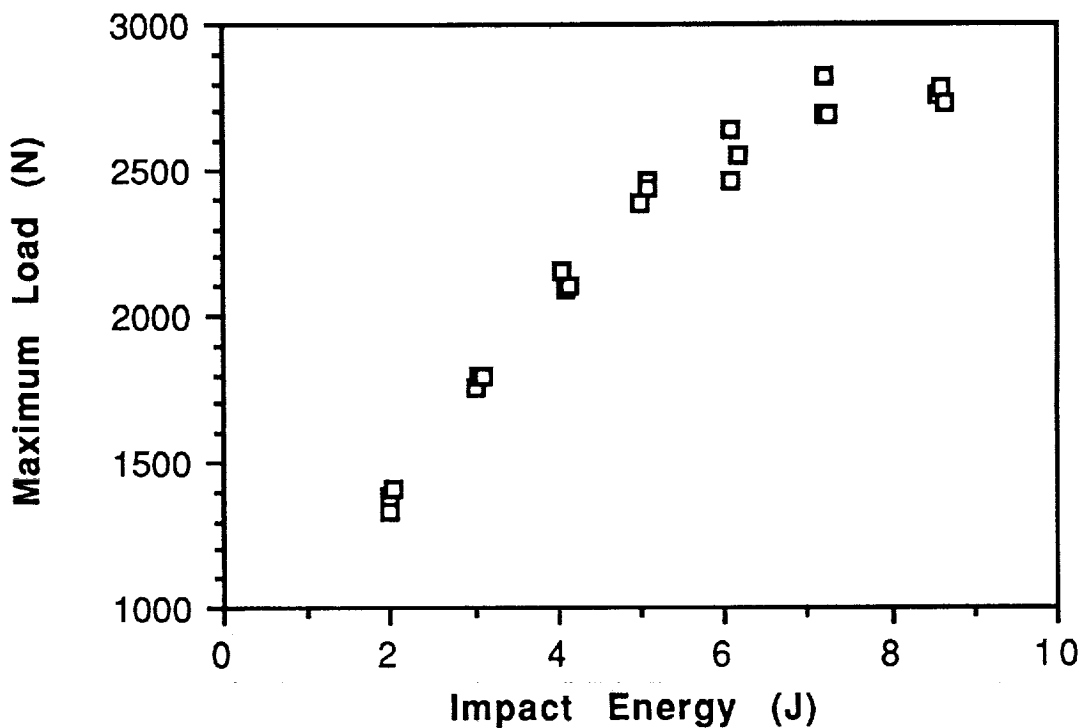
Figure 5. Maximum load versus impact energy for T300/948 with UHMWPE on both faces.

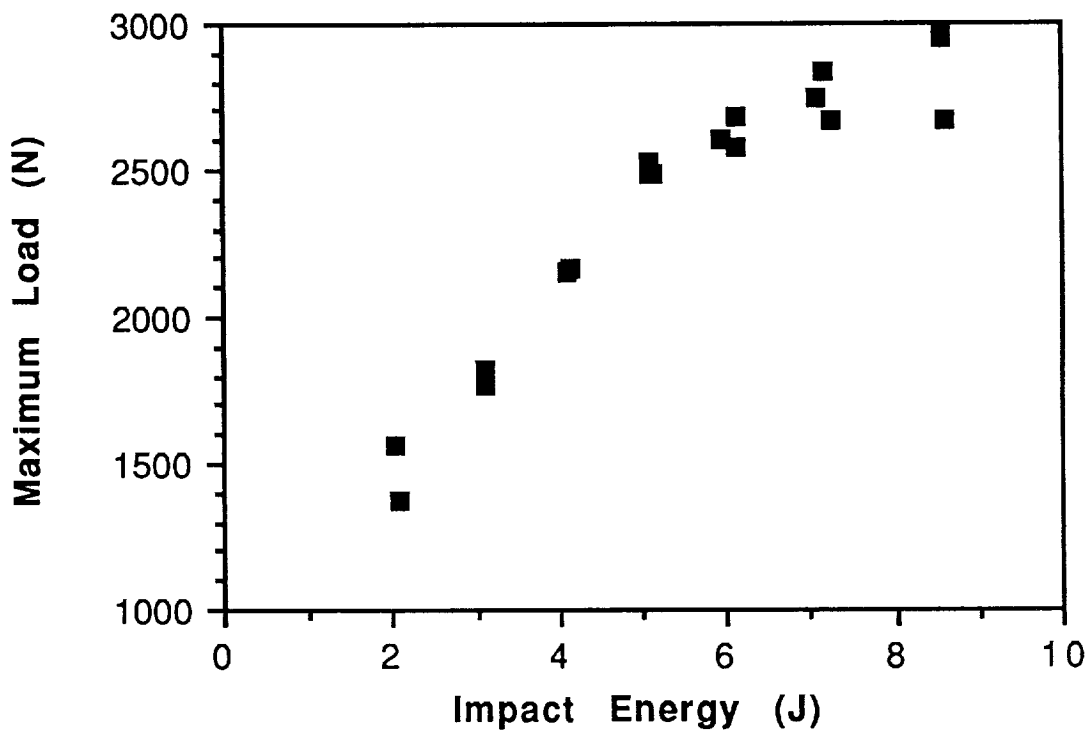
Figure 6. Maximum load versus impact energy for T300/948 with epoxy and UHMWPE on bottom face.

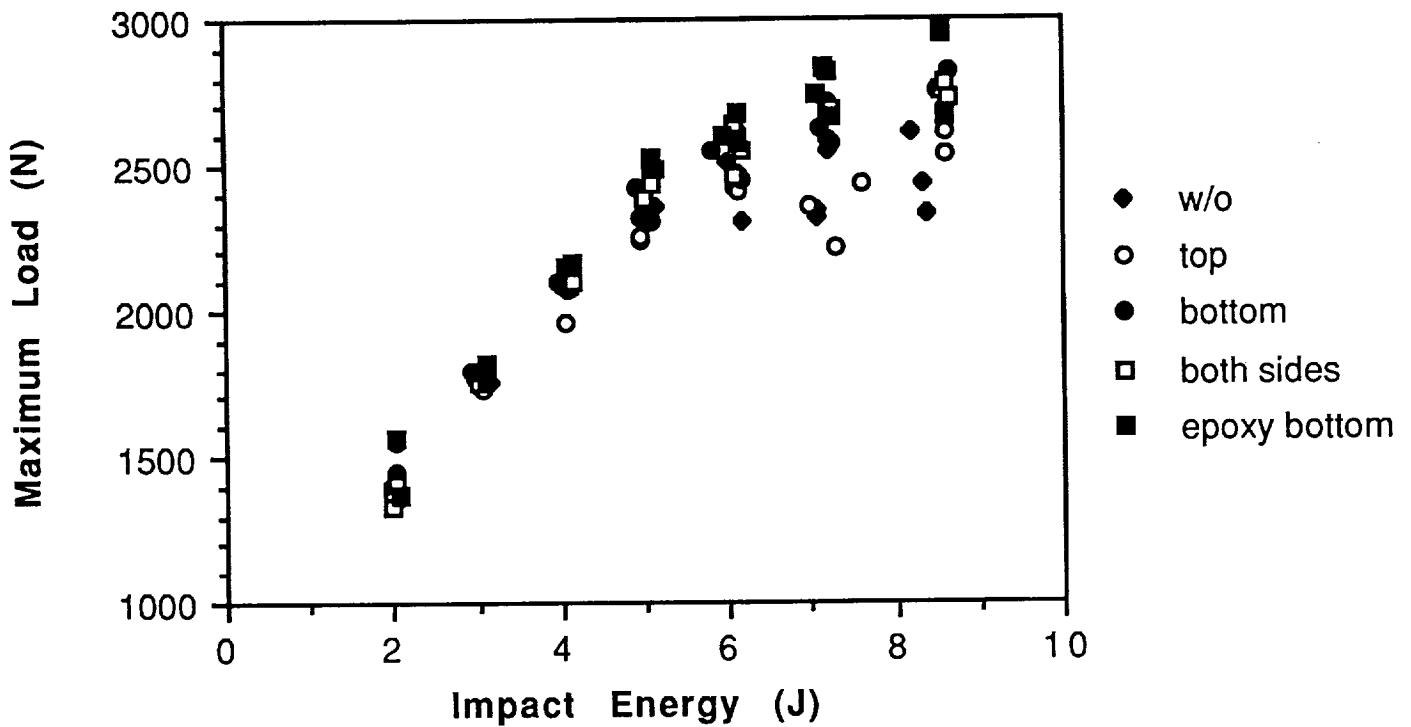
Figure 7. Maximum load versus impact energy for all configurations.

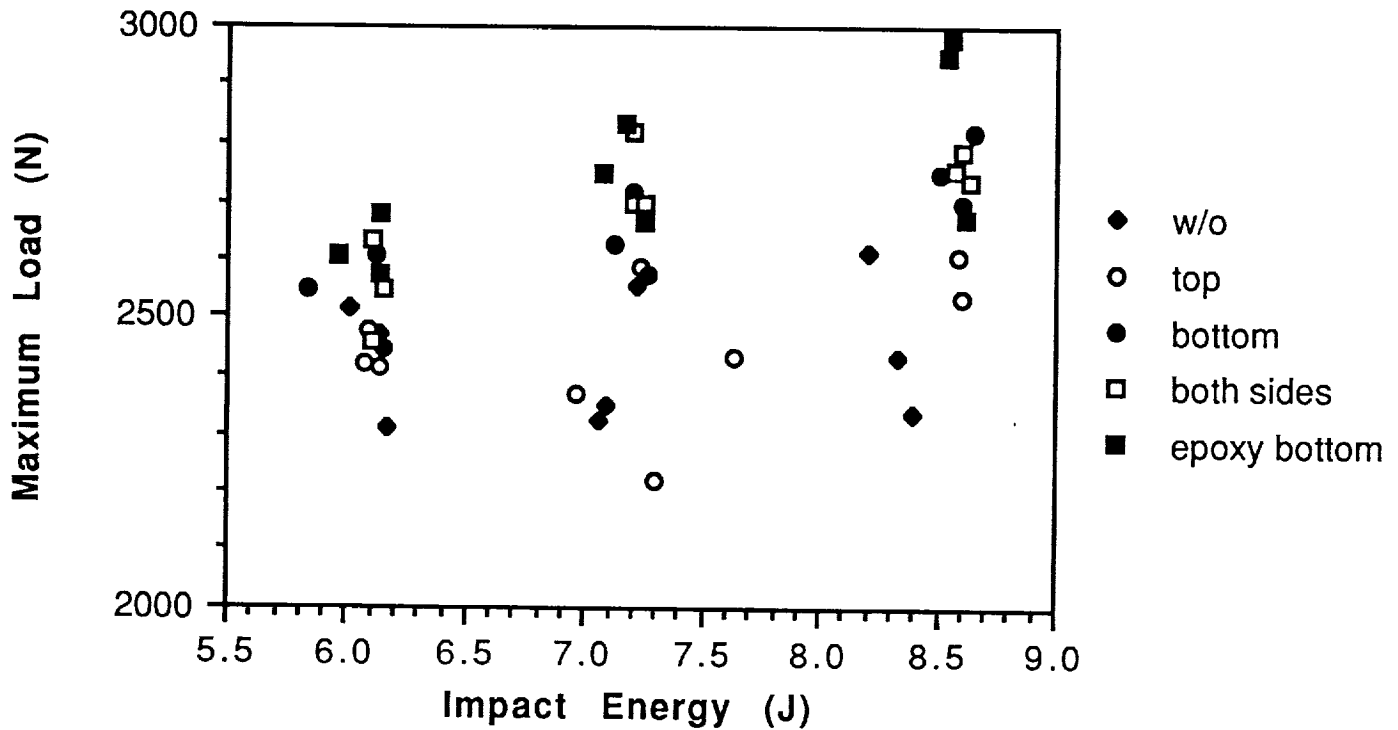
Figure 8. Maximum load versus impact energy for all configurations with magnified damage region.

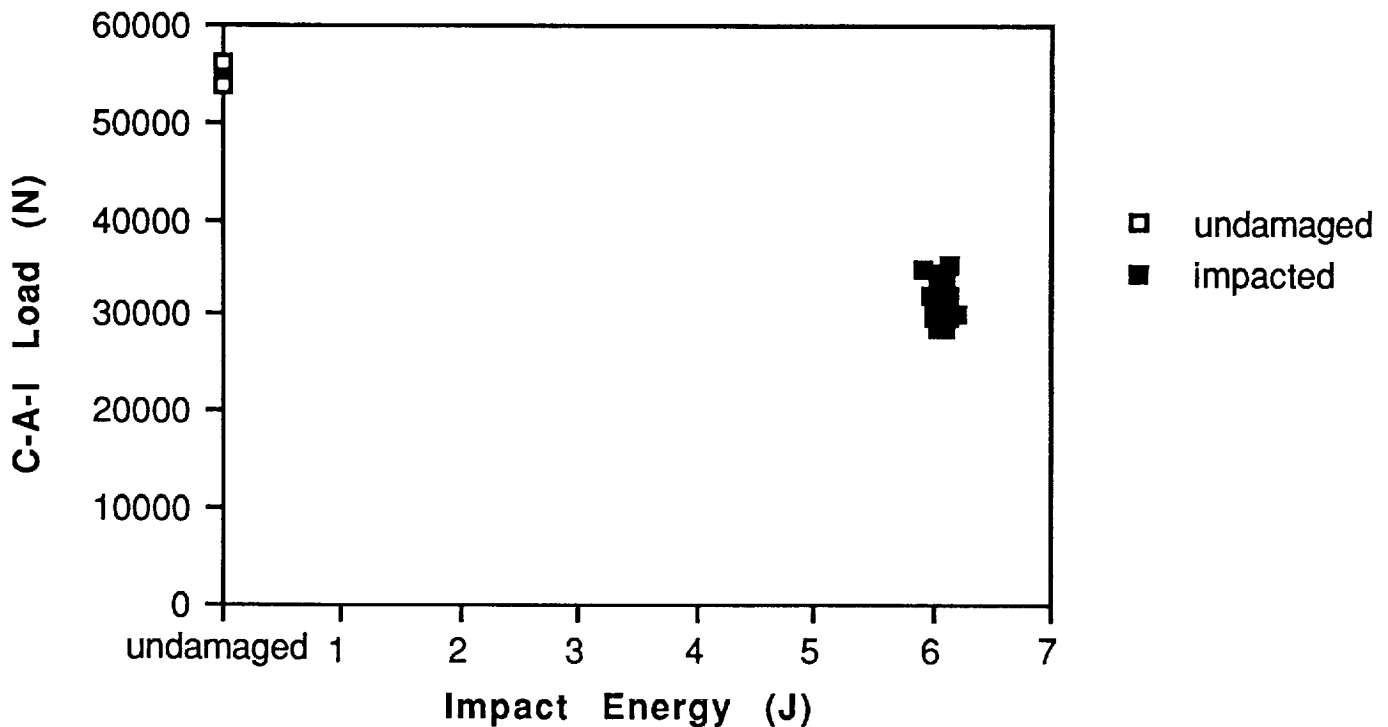
Figure 9. Compression-after-impact load to failure versus impact energy.

Graphs were produced which plotted the initial energy of the impact with the compressive load to failure. Figure 9 compares the resultant CAI load of the damaged specimens with specimens that were not previously impacted. It shows that specimens damaged by an impact of approximately 6 J had between 36 and 47 percent less compressive strength values than the unimpacted samples. Figure 10 compares the residual compressive strength of the various UHMWPE configurations previously impacted at an energy between 5.9 J and 6.2 J. Surprisingly enough, although the UHMWPE improved the load withstood under foreign object impact, the panels with UHMWPE had a lower residual compression strength. The lower CAI strength could result from a larger region of smaller delaminations in the specimen that seems to occur as the Spectra prepreg distributes the load of the impactor over a larger surface area.

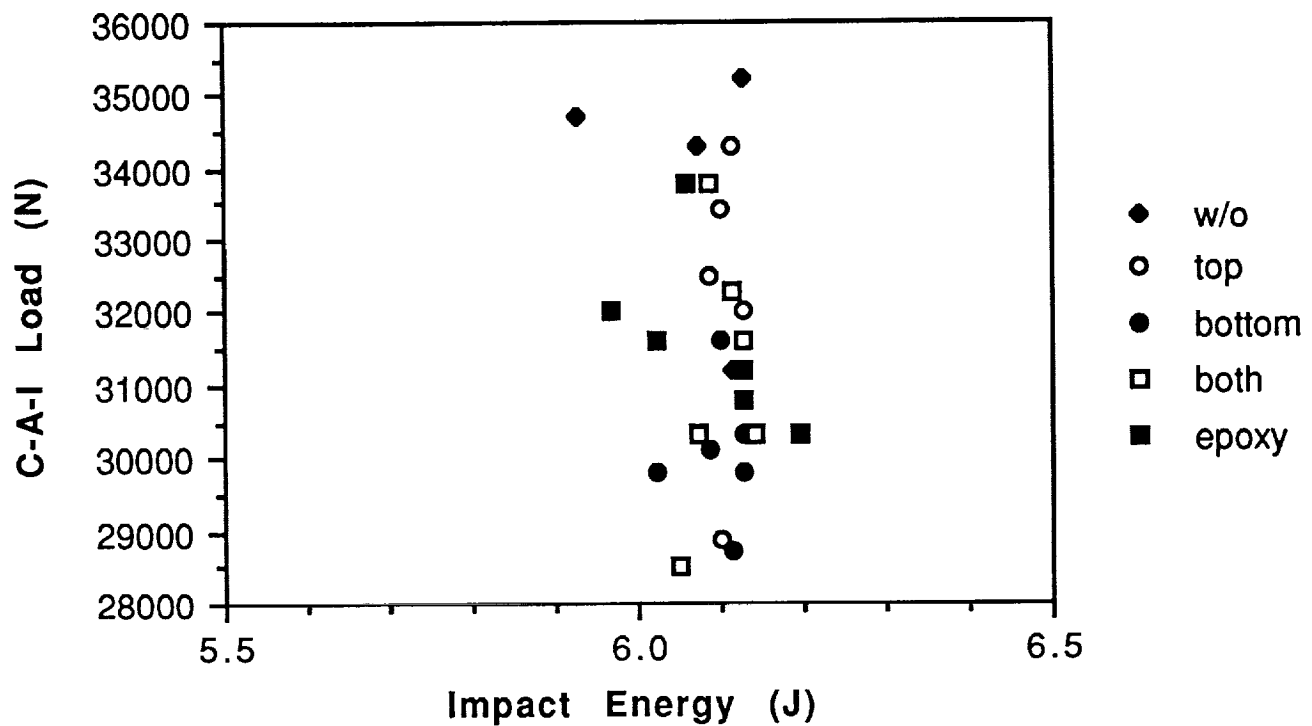
Figure 10. Compression-after-impact load to failure versus impact energy for damaged specimens.

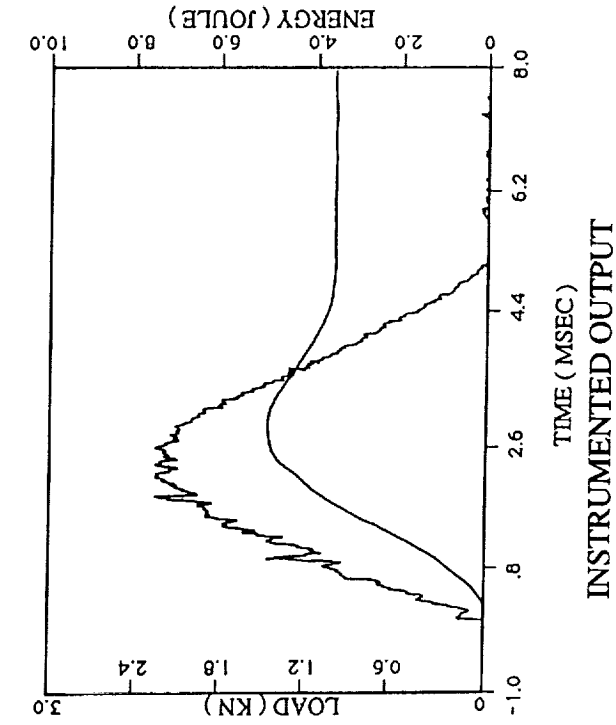
WITHOUT SPECTRA IMPACT ENERGY 5 J

INSTRUMENTED OUTPUT

CROSS SECTION

FRONT

BACK

The T300/948 plates without UHMWPE first displayed damage at 4.1 J when a crack appeared on the back (nonimpacted surface). At the 6.0-J energy level, a visible dent occurred at the impact sight. Fiber breakage was noticed on the back surface at the 7.1-J impact energy level.

The T300/948 without UHMWPE showed slight matrix cracks at the 3.1-J impact. Delaminations were visible at the 4.1-J energy level. Much fiber breakage was evident within the specimen impacted at 7.1 J.

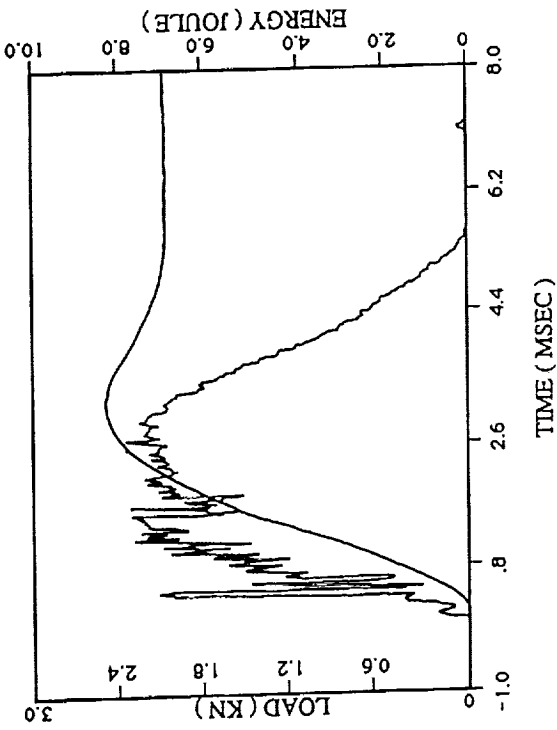
WITHOUT SPECTRA IMPACT ENERGY 8.5 J

INSTRUMENTED OUTPUT

CROSS SECTION

FRONT

BACK

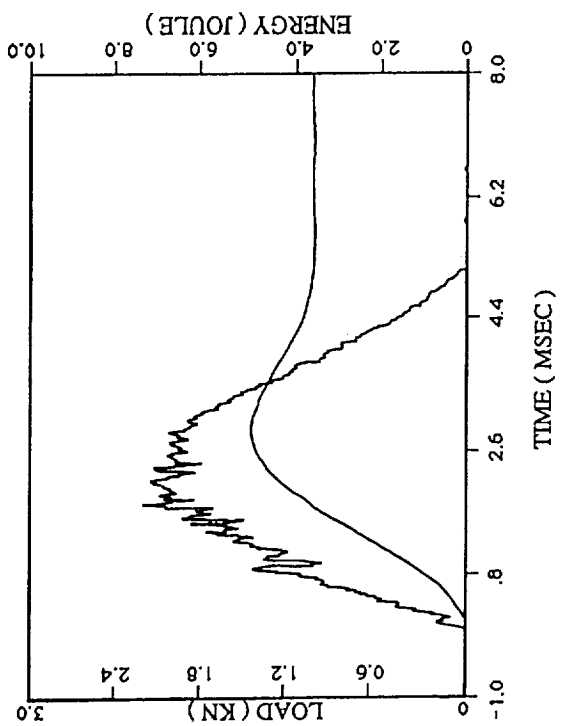
SPECTRA ON TOP IMPACT ENERGY 5 J

INSTRUMENTED OUTPUT

CROSS SECTION

FRONT

BACK

The T300/948 with a layer of UHMWPE on the top surface first sustained visible damage with a crack that appeared on the back surface at 4.1 J. A dent was noticed at the point of impact with the 6.1-J energy level.

The T300/948 with UHMWPE on the top surface showed minor matrix cracking at the 3.0-J impact and delaminations at the 4.1-J impact. Partial fiber breakage was noticed at the 6.1-J and 7.2-J impacts with much fiber breakage occurring at the 8.5-J impacts.

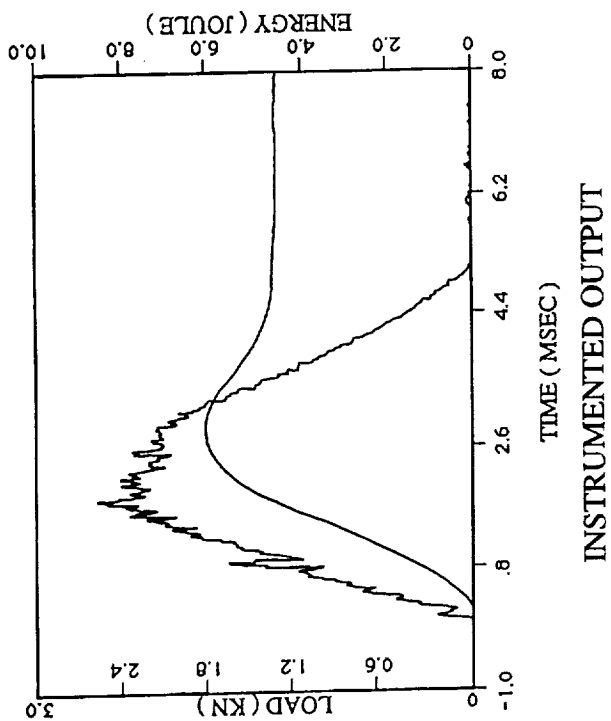
SPECTRA ON BOTTOM IMPACT ENERGY 6 J

CROSS SECTION

FRONT

BACK

The T300/948 with a layer of UHMWPE on the bottom surface prevented visible damage until 4.0 J when a slight mark was made on the back surface due to the crazing of the Spectra fiber. At the next impact level of 6.0 J, the back surface was significantly cracked beneath the layer of UHMWPE which accounted for the raised area of crazing. A dent occurred on the front at 7.2 J.

The T300/948 with UHMWPE on the bottom surface and the T300/948 on both sides behaved similarly. They displayed delaminations and matrix cracking in the 4.9-J to 5.1-J range. Fiber breakage occurred for both configurations at the 8.5-J impact although the extent of the damage was less for the composite with UHMWPE on both surfaces.

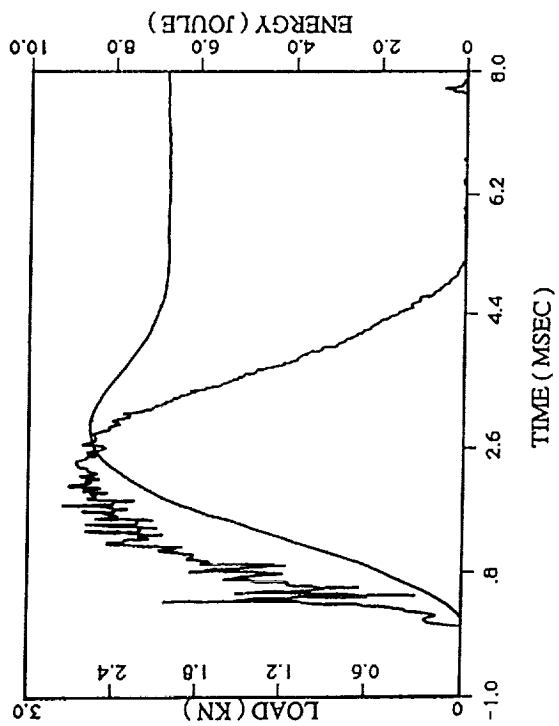
SPECTRA ON BOTTOM IMPACT ENERGY 8.5 J

INSTRUMENTED OUTPUT

CROSS SECTION

FRONT

BACK
